**RIVERSIDE ENERGY RESOURCE CENTER
SMALL POWER PLANT EXEMPTION
RESPONSE TO CEC DATA REQUESTS
04-SPPE-01**

Technical Area: Cultural Resources

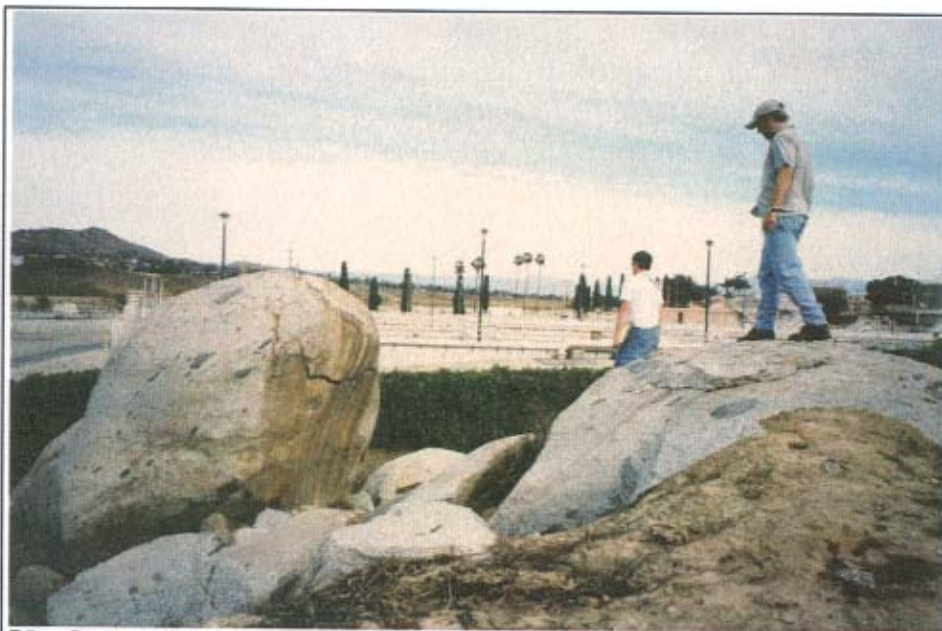
P5a. Photo or Drawing (Photo required for buildings, structures, and objects.)

Granite boulder outcropping with three bedrock mortars visible on the surfaces of two boulders. Two bedrock mortars are located on the surface of a large boulder with a low flat surface. The other bedrock mortar is located on an adjacent boulder that is smaller but similarly low lying. Larger boulders are also a part of the outcropping but have no cultural features. No associated surface artifacts were observed.

P5b. Description of Photo: (View, date, accession #) View facing east of bedrock mortar site, 22 December 2003.

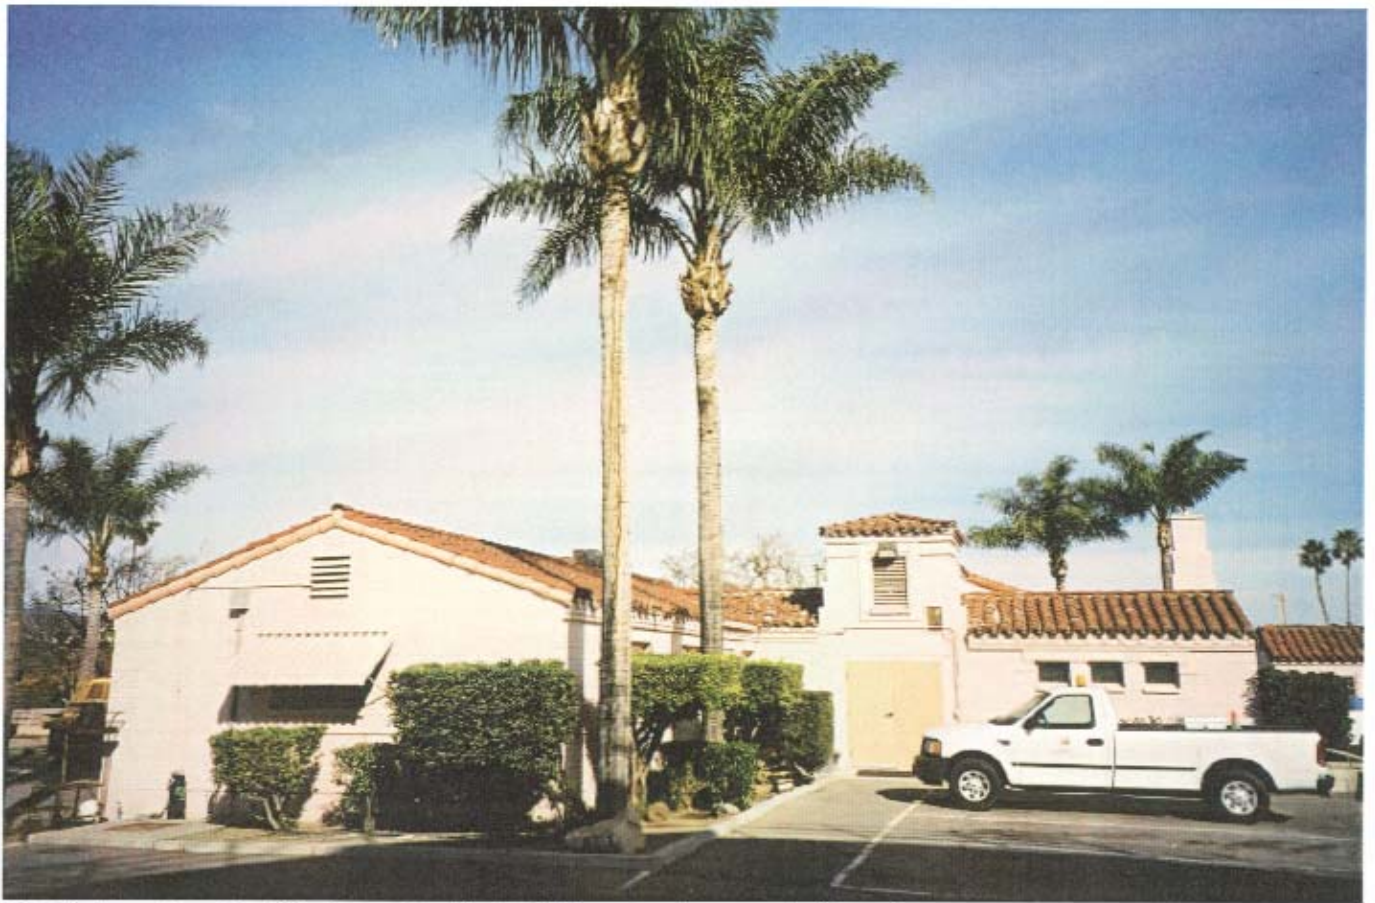
P5a.Photo or Drawing (Photo required for buildings, structures, and objects.)

- P5b. Description of Photo: (View, date, accession #)
1942 Wastewater Treatment Plant Office and Maintenance Building, Garage at right, camera facing north, 22 December 2003.

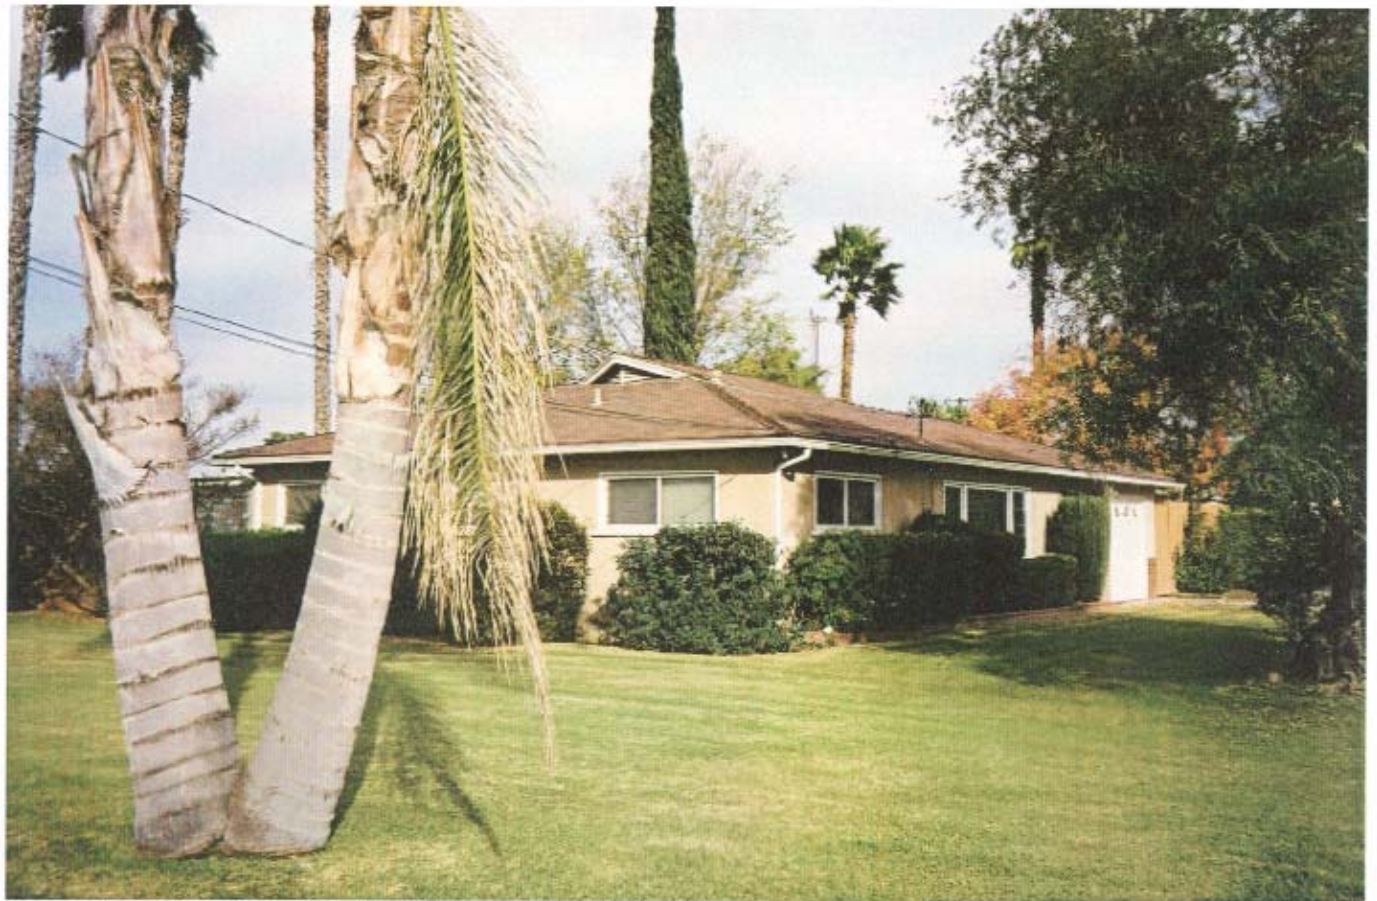
P5a. Photo or Drawing (Photo required for buildings, structures, and objects.)

One-story Ranch Style home under low hipped roof with Wrightian gable vents. Exterior materials are red brick wainscot at front (south) elevation and tan stuccoed walls, composition roof. Windows are horizontal sliding sash and one "Chicago" picture window centered at front. Single attached garage bay at right of entry door on front elevation. House is in good condition and appears to be among the last from a period when Jurupa Road hosted modest residences on large vegetated lots in this area.

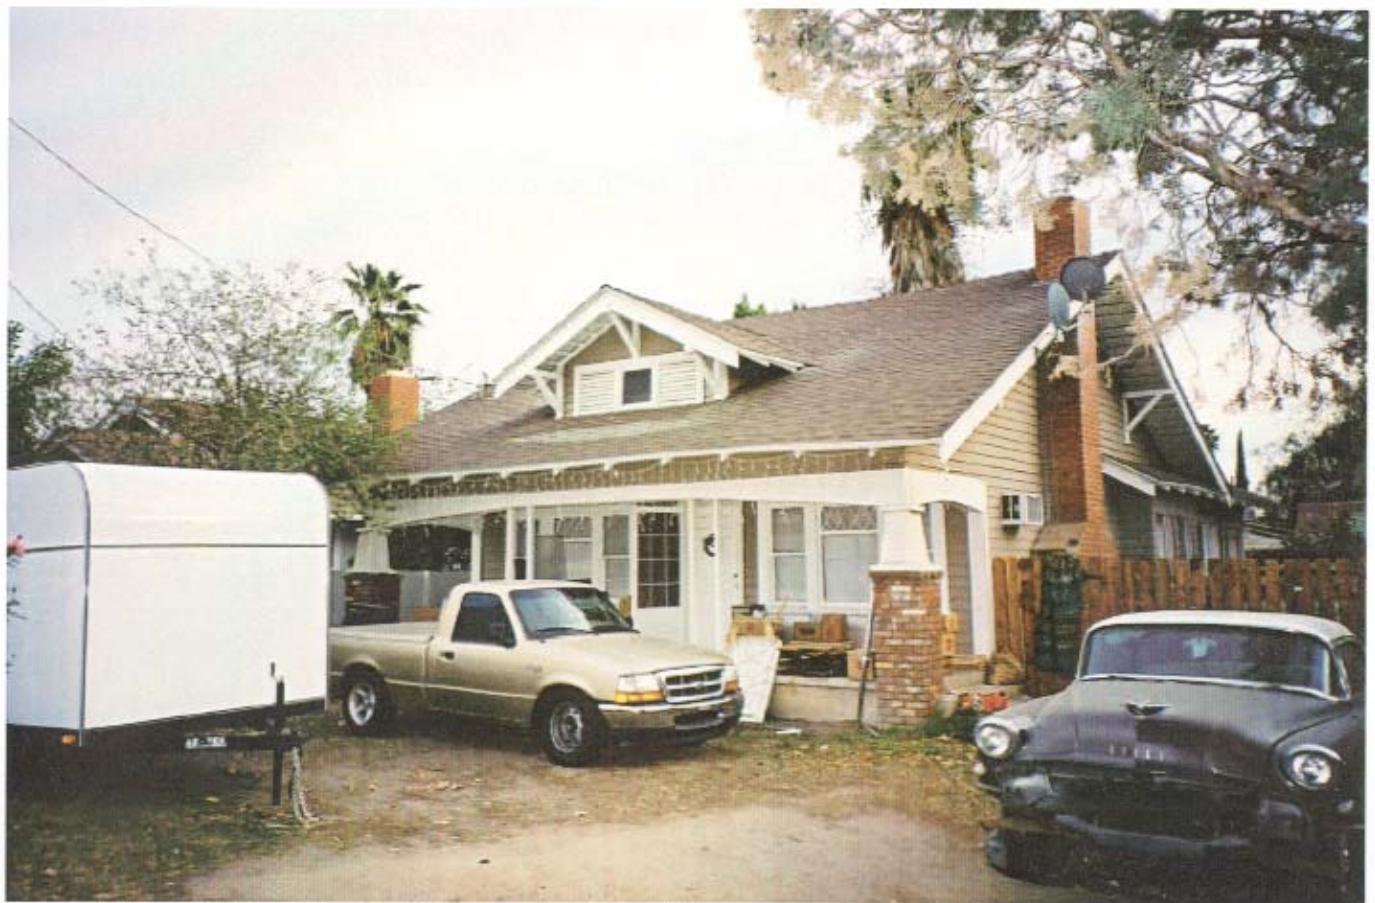
P5a. Photo or Drawing (Photo required for buildings, structures, and objects.)

One-story frame side-gabled California Bungalow with full-width front porch supported by corner brick columns and battered-wood caps, symmetrical fenestration of central entry door flanked by "Chicago" windows (center fixed pane of each topped by transom of x-pattern panes, central gabled dormer on composition-shingle roof, knee-brace brackets at all eaves, exterior red-brick chimneys flanking both sides. Good condition with few alterations (new front door, concrete porch), considerable landscape clutter on single urban residential lot.

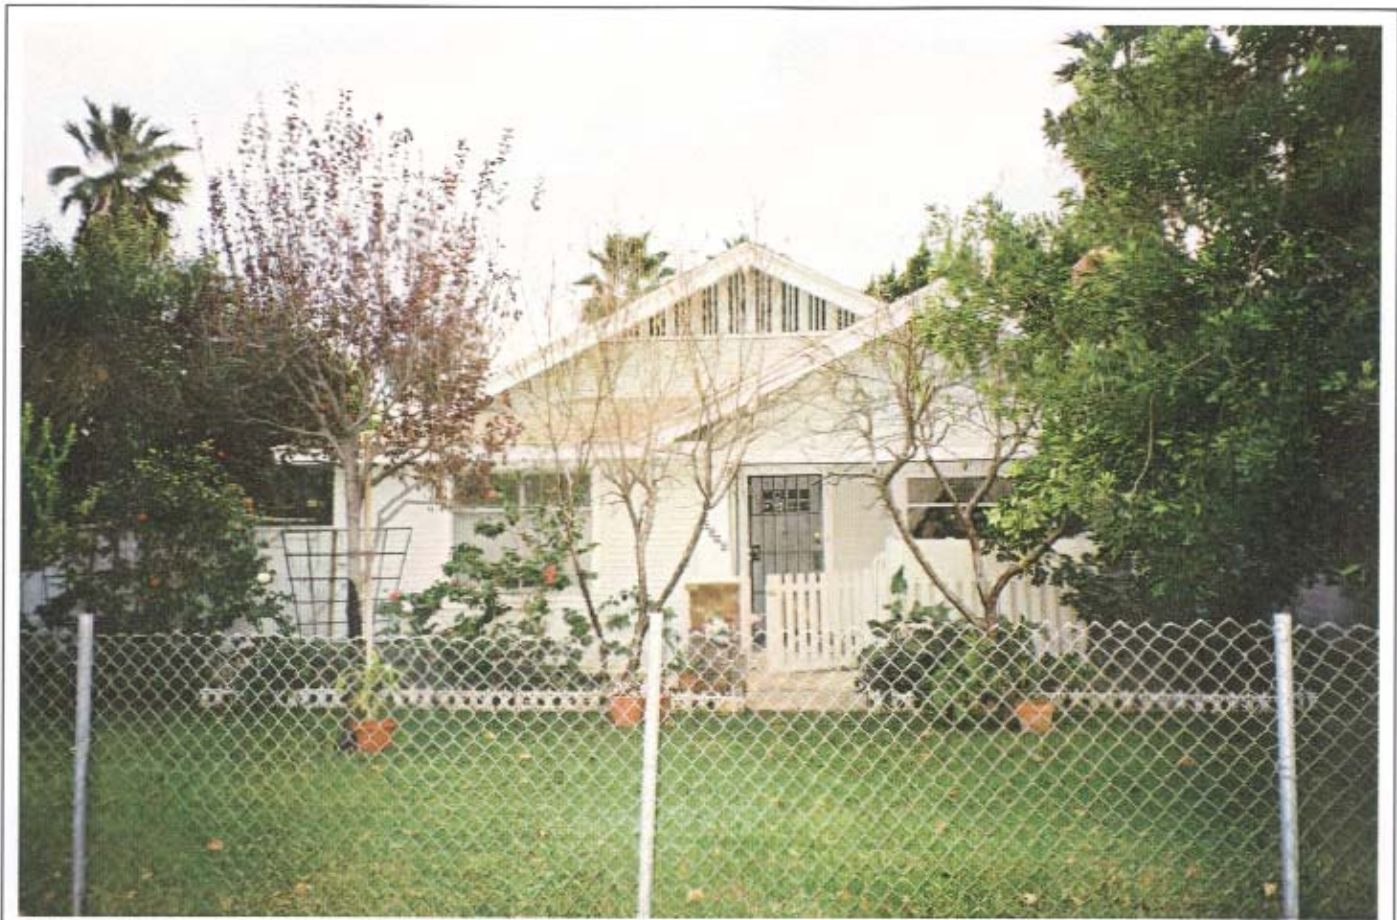
P5a. Photo or Drawing (Photo required for buildings, structures, and objects.)

One-story frame front-gabled California Bungalow with extended gabled bay (now infilled porch) creating asymmetrical façade, decorative gable-end attic vents under composition shingled roof, knee-brace brackets, exterior perhaps covered with new siding of #119 washboard pattern. Altered condition (porch infill, new front door, replacement windows not of original size), on single urban residential lot.

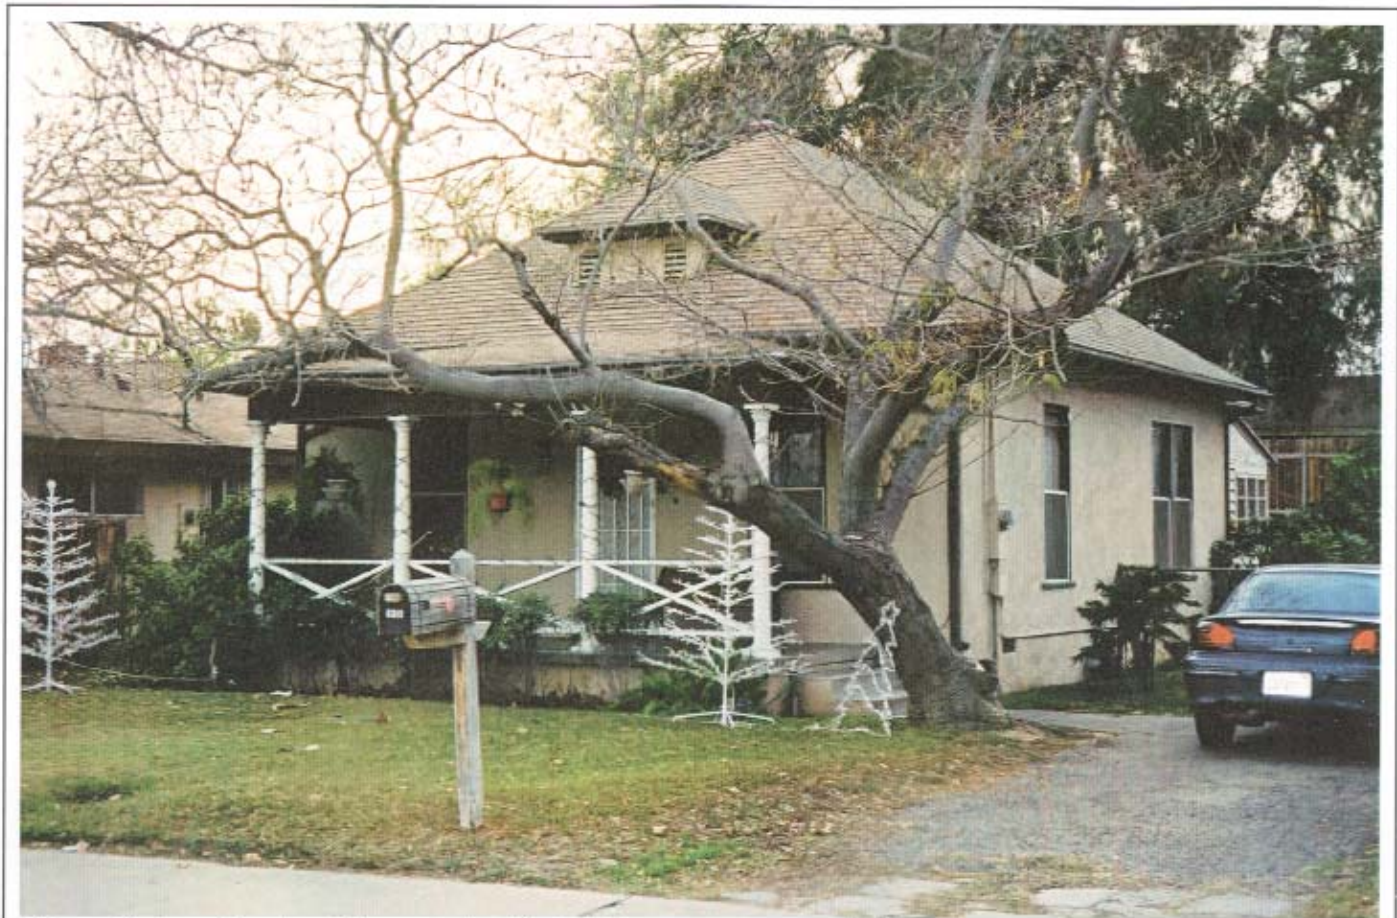
P5a. Photo or Drawing (Photo required for buildings, structures, and objects.)

*P3a. Description: (Include design, materials, condition, alterations, size, setting and boundaries)

*P3b. Resource Attributes: (List attributes and codes) HP2

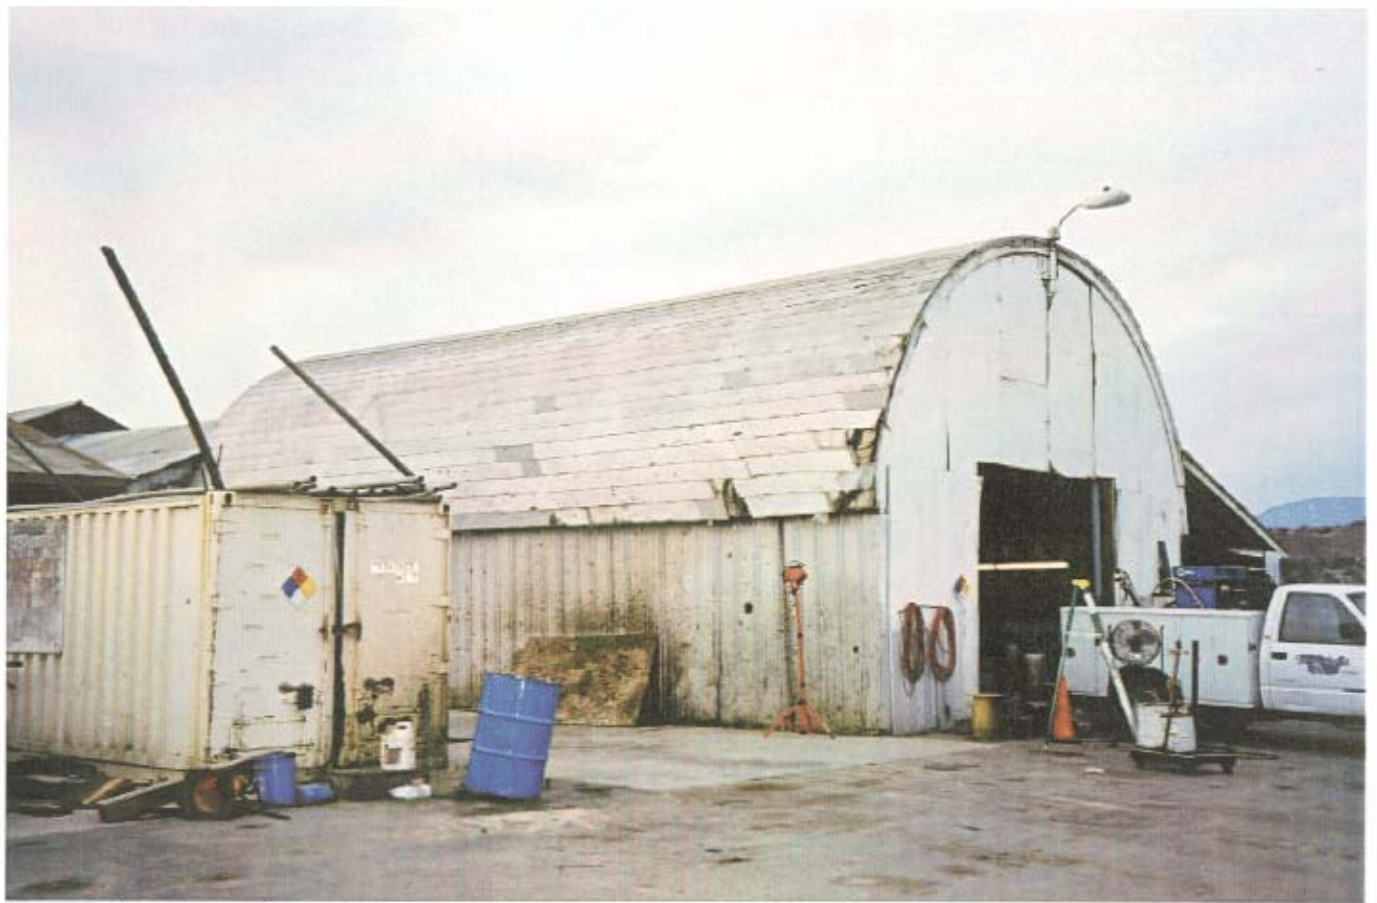
P5a. Photo or Drawing (Photo required for buildings, structures, and objects.)

*P3a. Description: (Include design, materials, condition, alterations, size, setting and boundaries)

*P3b. Resource Attributes: (List attributes and codes) HP4, HP33

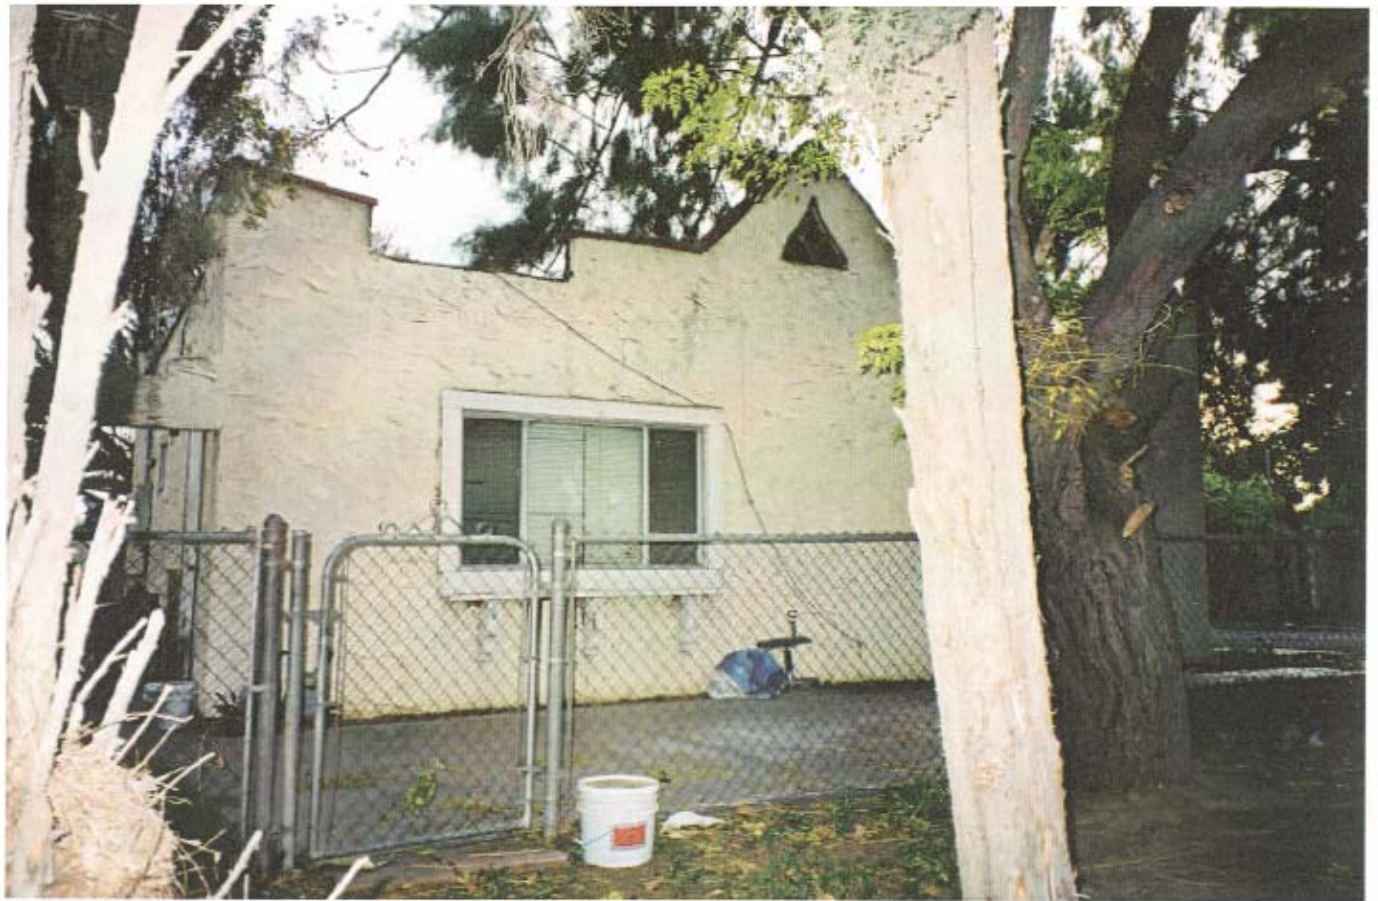
P5a. Photo or Drawing (Photo required for buildings, structures, and objects.)

*P3a. Description: (Include design, materials, condition, alterations, size, setting and boundaries)

*P3b. Resource Attributes: (List attributes and codes) HP2

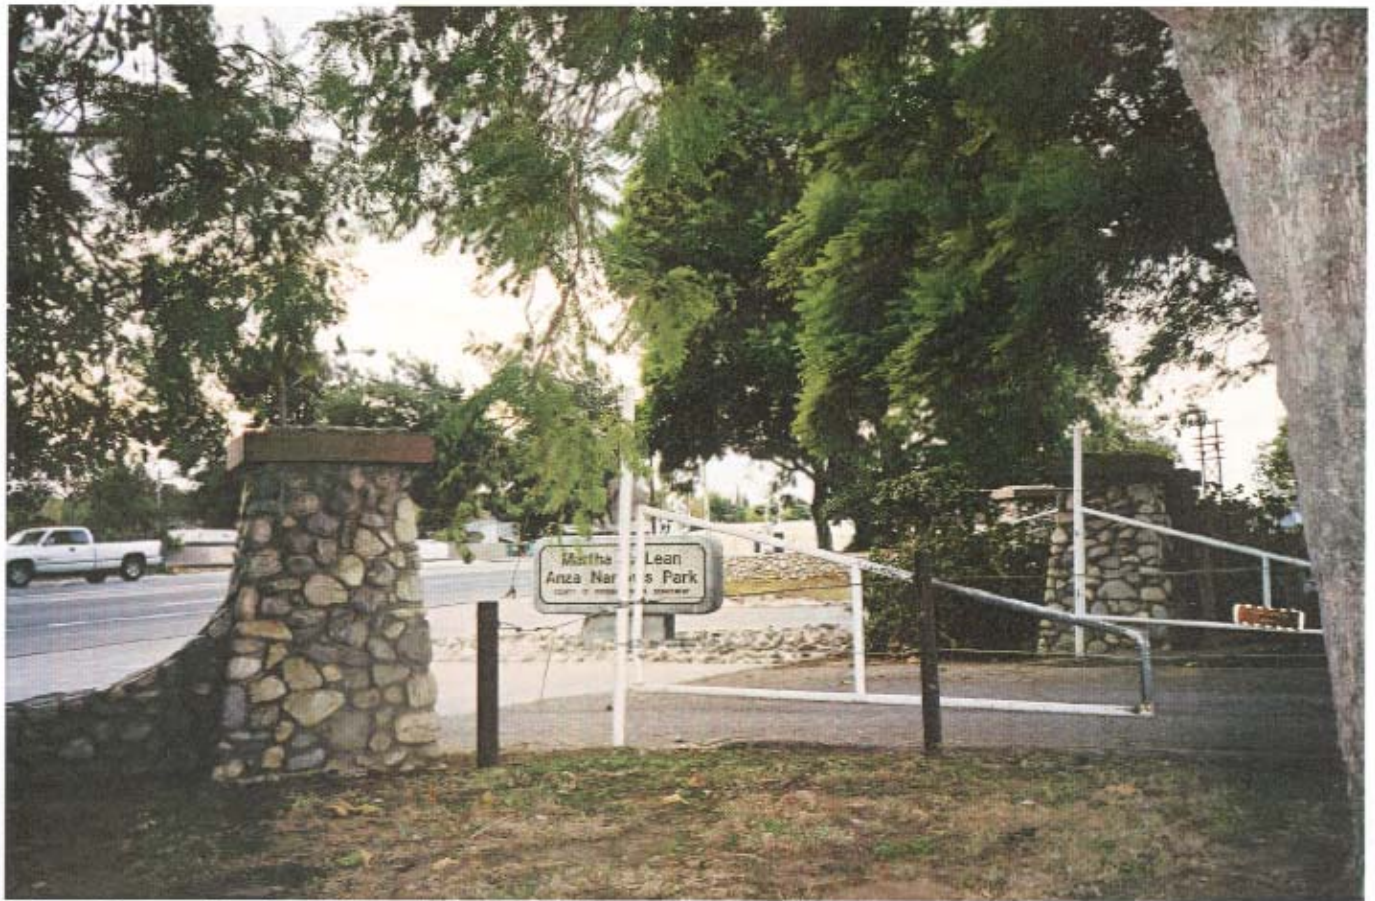
P5a. Photo or Drawing (Photo required for buildings, structures, and objects.)

This "Romantic Movement" park preserves and offers passive recreation opportunities along the rolling grounds of the Santa Ana River basin centered on Anza Narrows, a traditional crossing of the river. Entry gates to the park on Jurupa Avenue reflect Rustic Style design popular in late 19th to mid 20th century public parks, but could be well-executed recent construction. In the park on a bluff looking north over the Santa Ana River basin, a 1939 cast-metal marker, mounted on a low stone cairn, commemorates the de Anza Trail that brought a Spanish mapping expedition in 1774 from Tubac, Arizona, to San Francisco across this ford on the river. The park appears to have been established at least as early as the 1930s, with various improvements such as paved roads and trails, playground equipment and picnic facilities added through the late 20th century. Its condition is generally good, but its evolution from original designs and facilities to the present appearance should be investigated.

P5b. Description of Photo: (View, date, accession #)
Entry from Jurupa Avenue into park, camera facing southwest, 22 December 2003

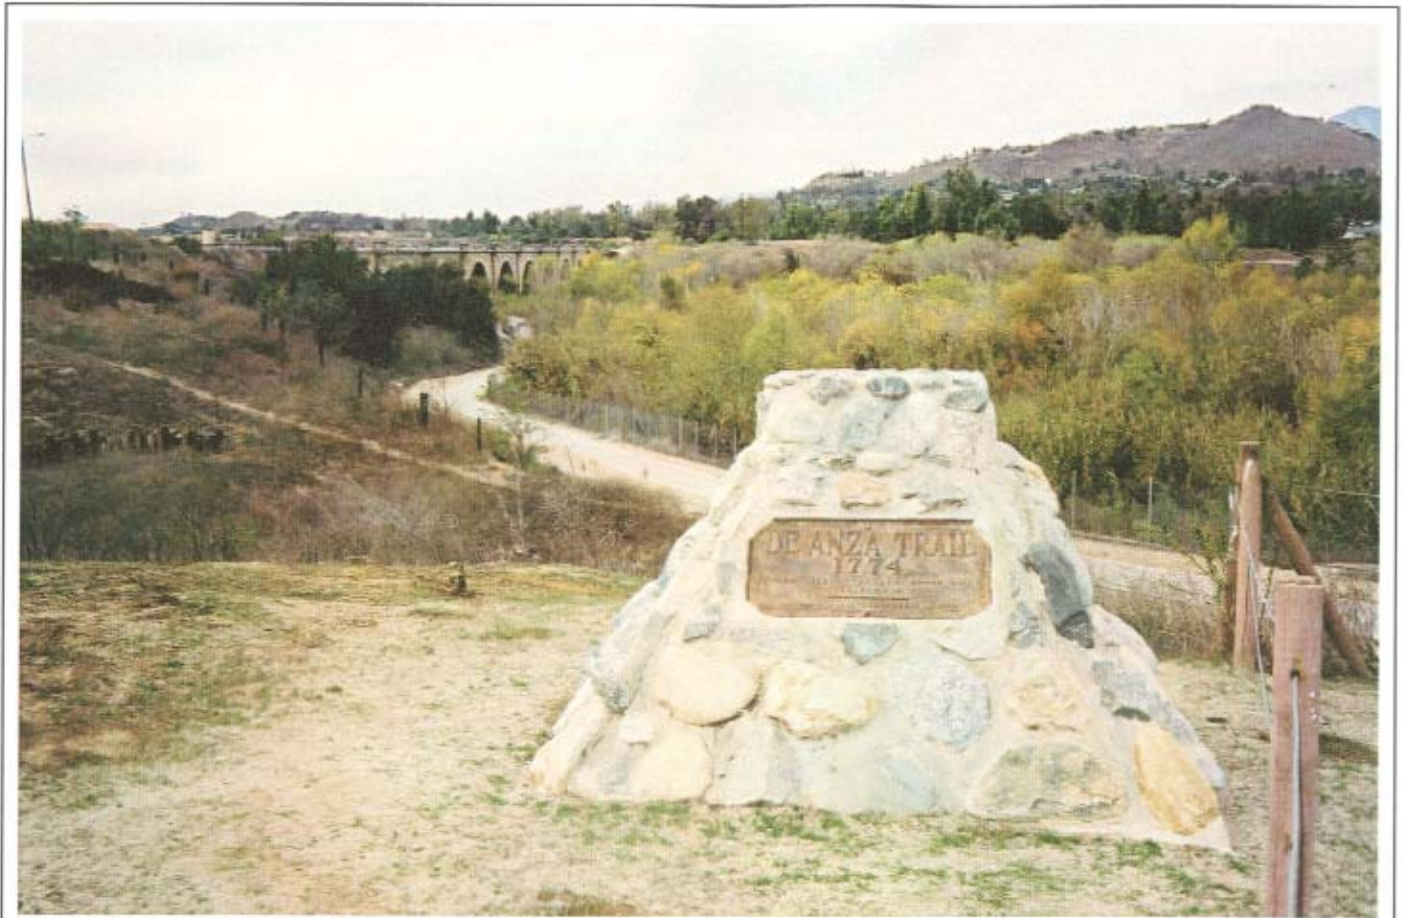
P5a. Photo or Drawing (Photo required for buildings, structures, and objects.)

P5b. Description of Photo: (View, date, accession #)
De Anza Trail marker (1904 bridge in background), camera facing north, 22 December 2003
